Clamping/Stretching Bar Binds

Problem: Clamping Bar or Stretching Bar Closing Slowly or Erratically

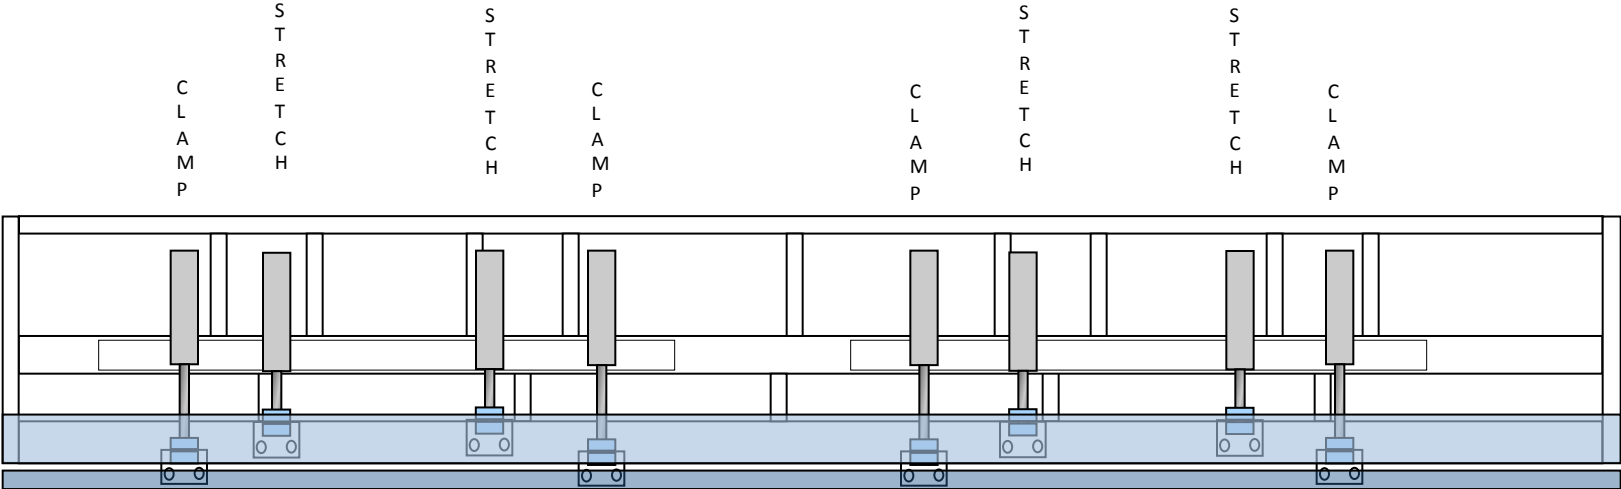
In the drawing below you will notice a generic representation of the cylinders and their orientation. This machine has (4) clamping cylinders and (4) stretching cylinders. The idea is to get all (4) of the same circuit traveling at the same rate and same distance.

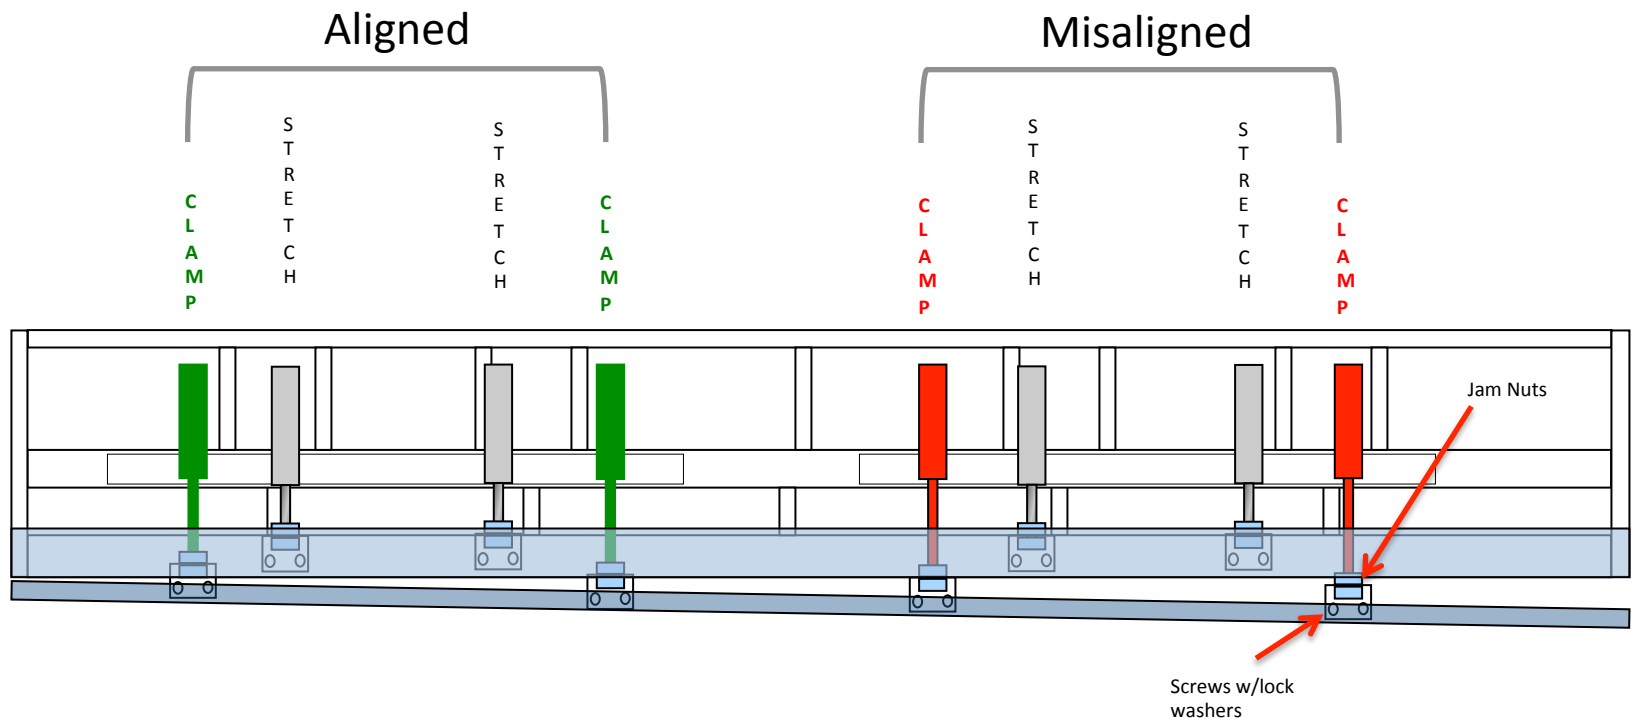
The drawing below shows an exaggerated example of what might happen when the clamping bar is out of alignment.

The two clamping cylinders on the right are extending slightly further forward than the two on the left. This occurs when the “jam” nuts loosen or cinch-up during transit or operation. This can also occur when one or more screws becomes loose or has cinched up too tight.

The first thing to determine which side is the problem. In the example below the right side has not retracted when the air has been removed. In this case one, or both, of the clamping cylinders on the right are extending slightly forward. The jam nut is the most likely culprit but it can also be caused by the mounting screws on the small angle bracket as well.

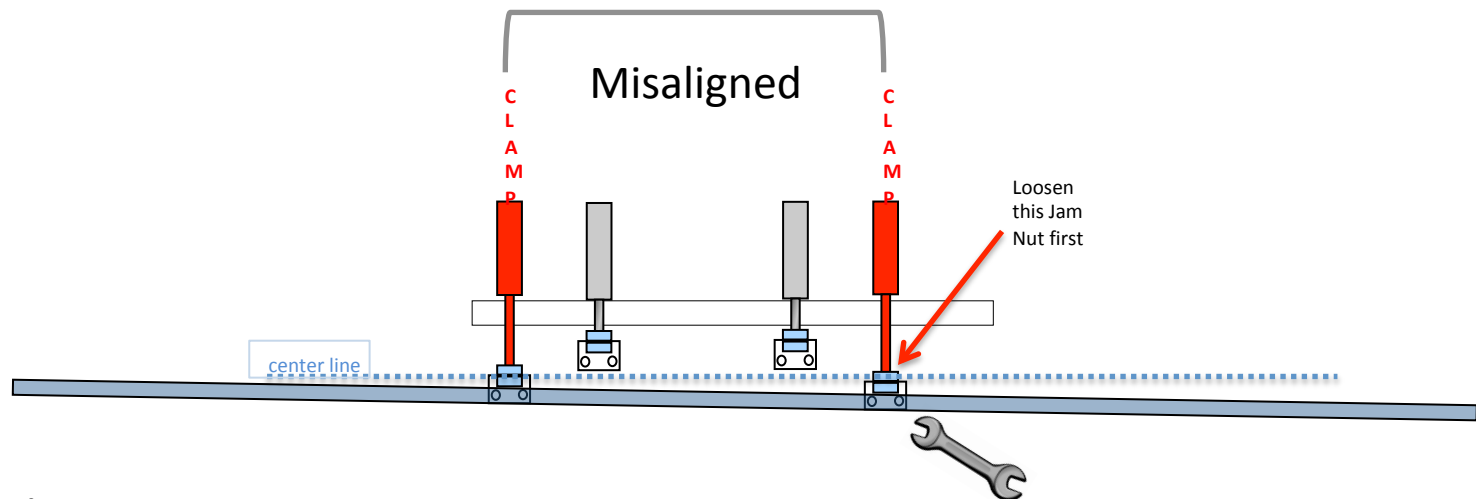
In the drawing below you will notice that the two clamping cylinders (only shown for one side) have traveled slightly further forward of the centerline than the (2) left cylinders. The ideal scenario is for all (4) clamping cylinders to travel the same distance and at the same rate. Because they are traveling further forward they cause the bar to bind as shown.

Before even attempting an alignment it is possible to view the bars from one side of the machine to see if they extend any further than the other. We are not looking for a perfect straight line because that is not even remotely possible. The aluminum bars themselves are not perfectly straight.

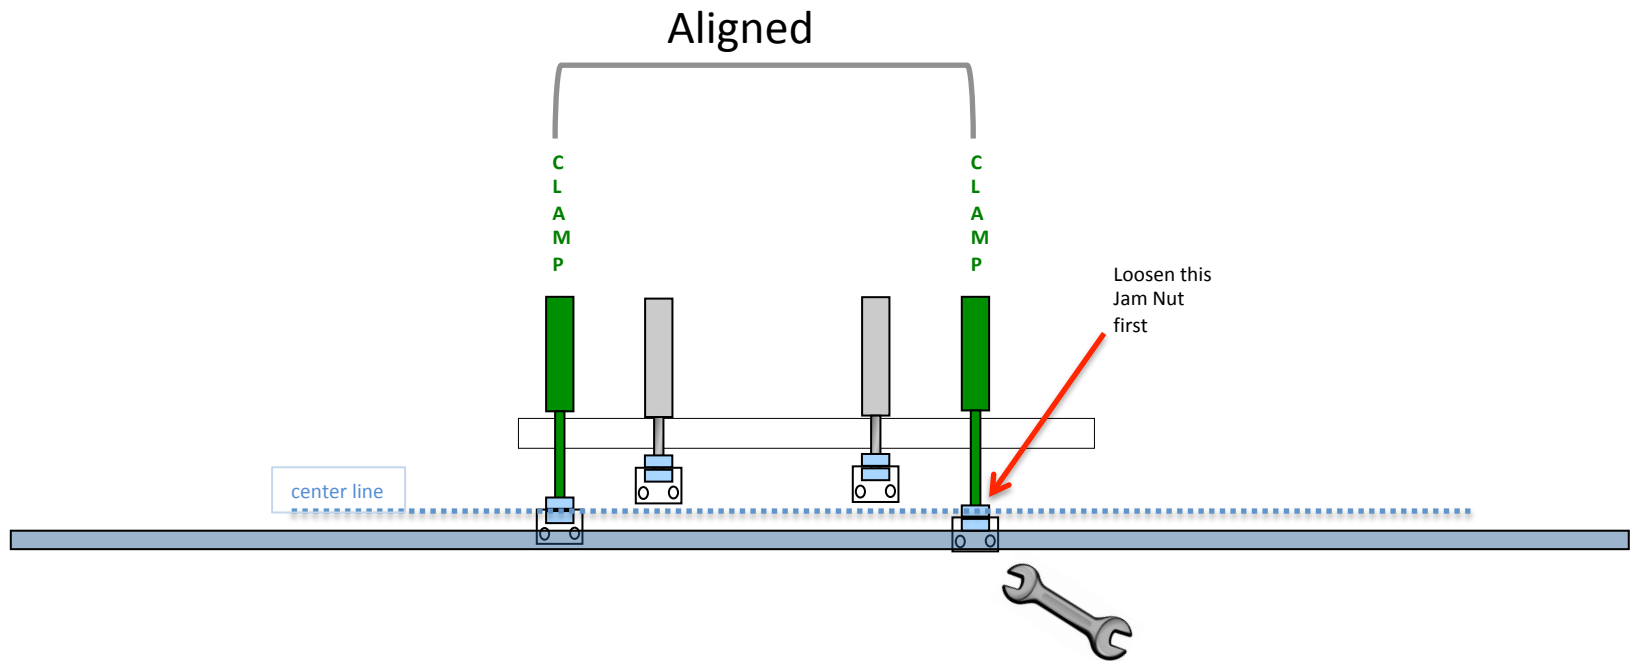
One indicator that your bar is in alignment is that it pops back into alignment with the rest of the cylinders. Look down the length of the machine from the side again and see if you notice any cylinder out of alignment.

Take an 11/16 open end wrench and loosen the jam nut furthest from the front. If the bar does not retract immediately loosen the other jam nut on the second clamping bar. In most cases this will solve the problem. Then tighten the front jam nut to secure it. In some cases you may have to move the rear jam nut back a little more until the bar retracts or until it operates smoothly. Always move the front jam nut firmly against the bracket. The same procedure is done for clamping or stretching bar.

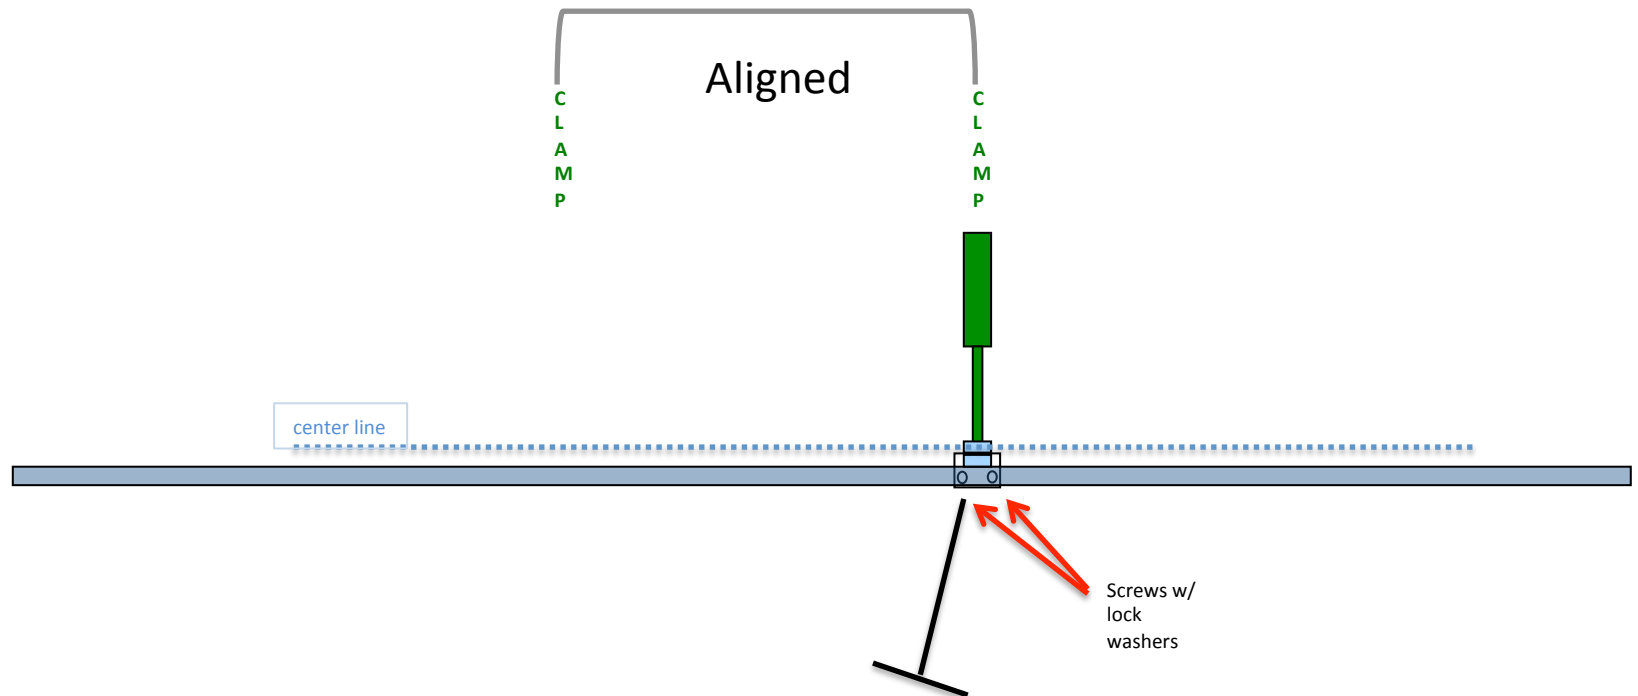
After you identify the effected cylinders and get the bar to retract you may still notice that the bar travels a little erratically. The jam nuts allow the cylinders to be moved forward and backward so that all of the cylinders are in alignment, but the small angle brackets, as viewed from beneath the machine, are what holds the cylinder in a straight line. If one or more of the mounting screws is loose or should experience a bit too much torque from side to side then this too will cause an alignment issue.

After repositioning the jam nuts go down the length of the bar with your "T" wrench, provided, and loosen the two screws on each bracket that mounts the cylinder to the bar and then immediately tighten them. Listen for a "popping" sound or visually check to see if the bar shifted. Do this the entre length and then test the travel. This should correct your alignment issues.
